A New Life for Prime Western Smelter Site In Gas, KS

*By Gary Blackburn, Director
Bureau of Environmental Remediation*

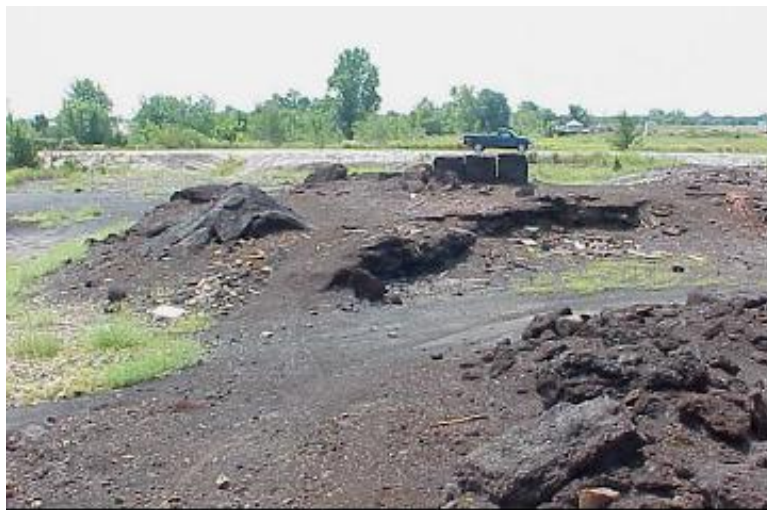
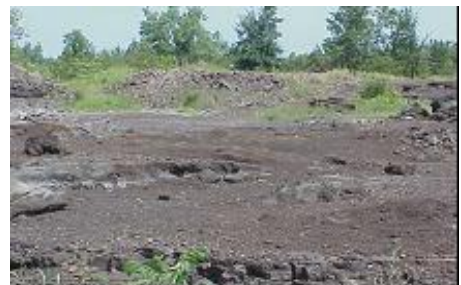
August 2002. (Left) Cinders, slag, and debris covered the surface at the location of one of the former smelter works. Soil in this area was so contaminated that it was unable to support vegetation. (Below) It was chosen as the repository for soil from the rest of the site.

KDHE and EPA worked together to develop a plan to address the site and protect the public. Massive foundations, extensive slag, and thick deposits of cinders in one 25-acre parcel made excavation impractical, and the area was chosen as a repository. Contaminated soil was excavated from surrounding properties, moved to the repository, mixed with a stabilizing agent to prevent future migration of the metals into groundwater, and spread to form a smooth surface.

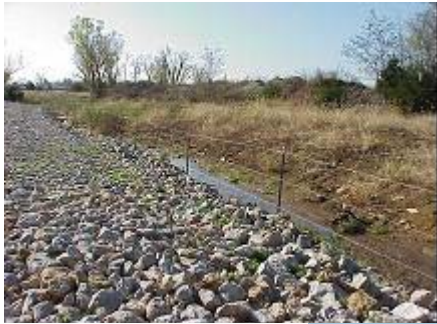
August 2004 - Construction of the repository.
Stabilized (dark) soil is being spread and covered with clean brown clay. Stockpiles of stabilized soil can be seen on the right.

A clay cap was placed over the stabilized soil, and graded to promote natural drainage and prevent erosion. A final layer of topsoil and grass seed completed the cover. Rock was placed on steep banks along existing drainage ditches to prevent erosion. The repository

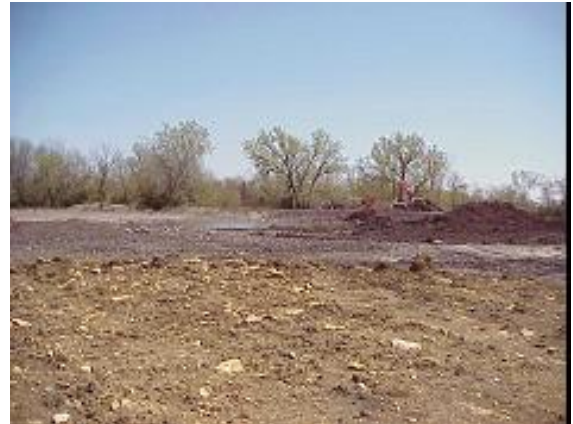
Above: A rocky bank along the west fence of the repository.

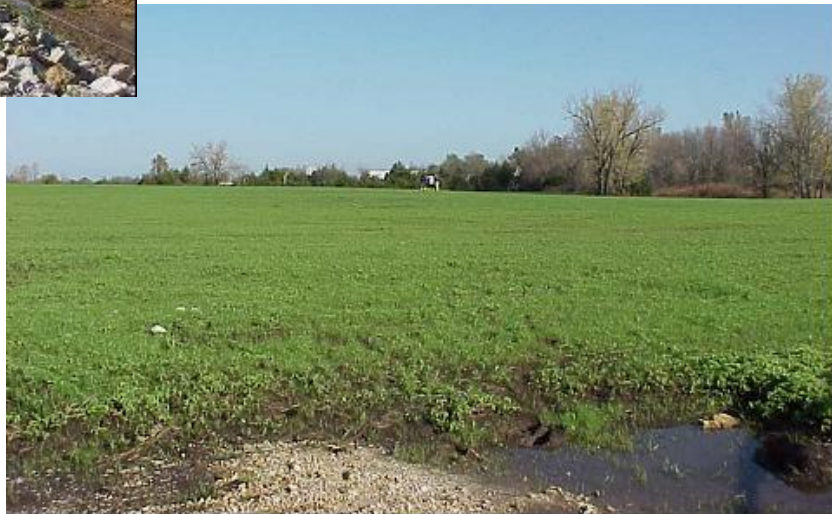
Right: Looking north from the south entrance. This is the same area shown in the August 2002 photos.

November 2004 - Completed repository.

was fenced to restrict access, and will be inspected regularly to ensure that the cap is not deteriorating. The owner of the repository site agreed to file a deed notice restricting future use of the land to activities that will not damage or penetrate the cap.

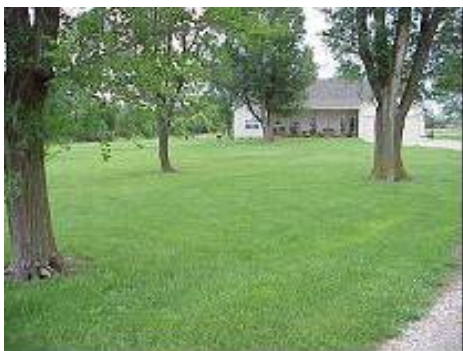
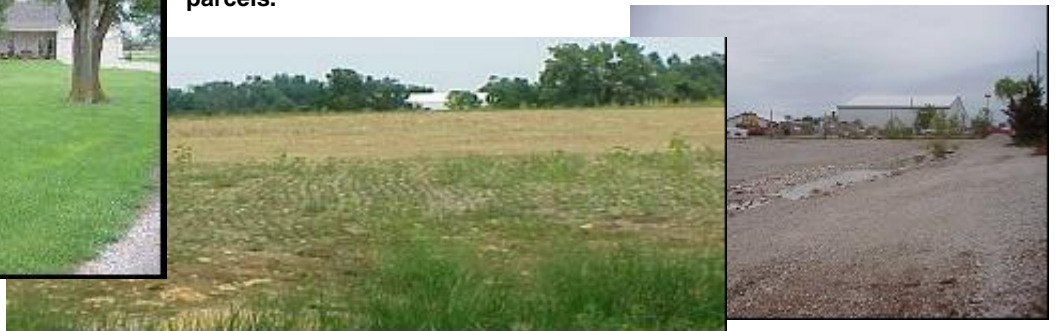
Restored residential (left) and non-residential (center and right) parcels.

Residential lots were excavated until remaining soil was below 400 mg/kg, backfilled with clean soil, and seeded with grass. Non-residential areas were excavated until remaining soil was below 1000 mg/kg. These areas were either covered with gravel, backfilled and seeded, or re-graded and seeded, depending on previous condition, the owner's preference, and cost equivalence.
